# Imaging water ingress into concrete using electrical resistance tomography

Suryanto, B, Saraireh, D, Kim, J, McCarter, WJ, Starrs, G & Taha, HM 2017, 'Imaging water ingress into concrete using electrical resistance tomography', *International Journal of Advances in Engineering Sciences and Applied Mathematics*, pp. 1-10. <https://doi.org/10.1007/s12572-017-0190-9>

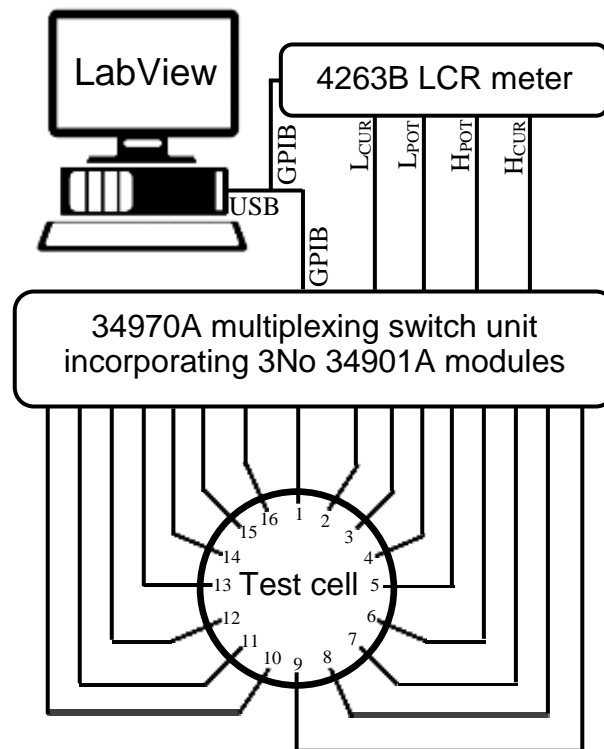
**Fig. 1** Schematic diagram of the measurement system.

158 The measurement system used in the current work comprises four main components: an Agilent 4263B LCR  
159 meter; an HP 34970A multiplexing switch control unit incorporating three 34901A modules; a desktop  
160 computer (PC) and a sample test cell containing a 16-electrode array (see Figs. 1 and 2). Communication with  
161 the measurement and multiplexing instruments was established across a GPIB system, which was accessed by  
162 the PC via an Agilent 82357A USB/GPIB interface using Keysight IO Library Suite software.

163 In order to manage the overall running of the measurement system, a fully automated data acquisition and  
164 control system was developed using LabView. This system facilitates the injection of current and subsequent  
165 potential measurements at repeated time interval, allowing virtually continuous monitoring of  
166 processes/variations in the material under test. In the present study, both injection and measurement protocols  
167 were set following the adjacent pattern [28], which was chosen for its simplicity. One measurement cycle  
168 typically involved 16 current injections and 13 potential readings for each current injection, thereby resulting in  
169 a total of 208 readings. Each measurement cycle took approximately 35 seconds to complete. To facilitate ERT  
170 measurements, the 4263B LCR meter was used in 4-point mode, with the current generated at the input  
171 terminals by a constant voltage of 350mV rms operating at a frequency of 1kHz, and with the potential

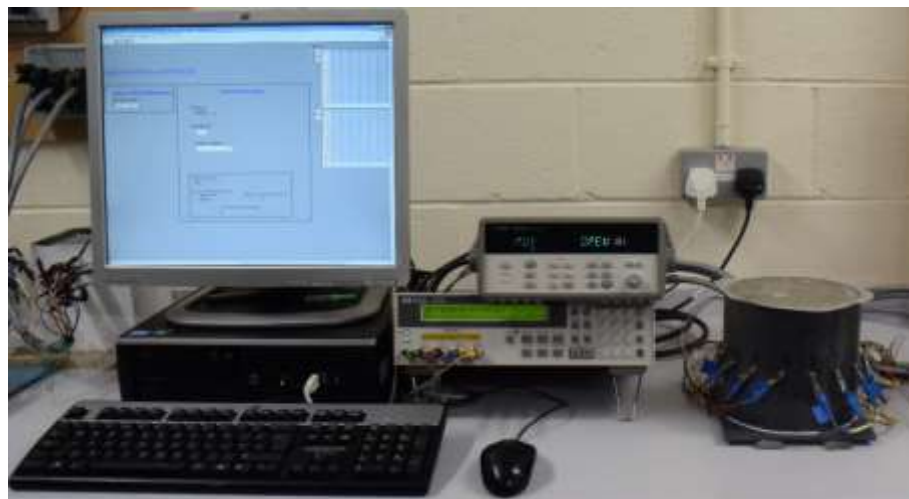
**Fig. 2** Hardware for the EIT measurements and test specimen.

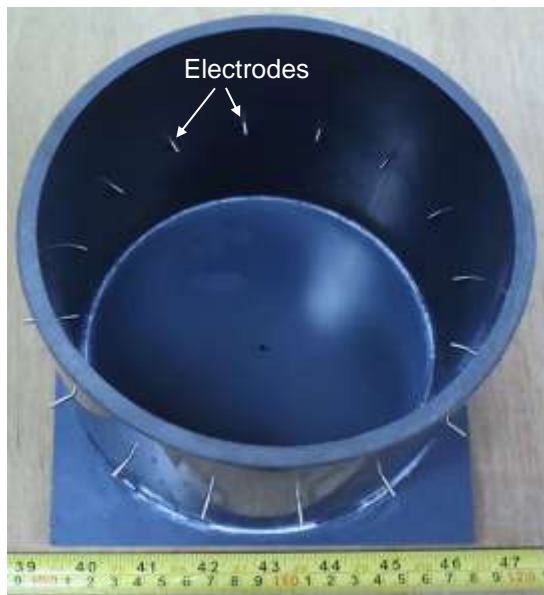
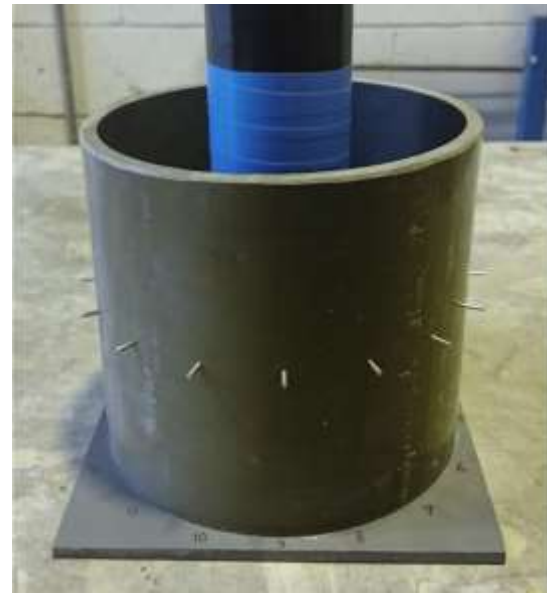
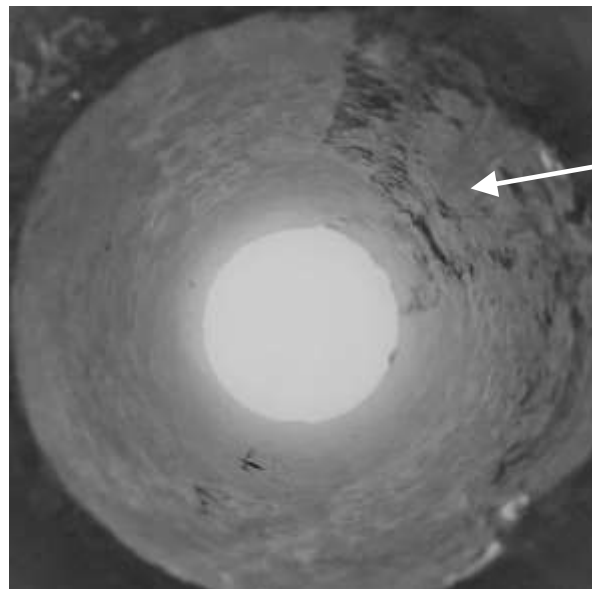
Rough/uneven  
surface texture on  
inside surface of  
cylinder

**Fig. 3** Test cell (a) without and (b) with the centre pipe; and (c) close-up on the inner circumferential surface of the test specimen after demoulding. Rough and uneven surface texture was evident primarily between 2<sup>nd</sup> and 5<sup>th</sup> electrodes.

The test cell was a 5mm thick cylindrical PVC mould, with an internal diameter of 154mm and a height of 150mm (see Fig. 3(a)). The mould was glued to a square 5mm thick PVC base-plate of edge length of 180mm. At the mid height of the mould, 16 equally spaced 2mm-diameter stainless steel pins (Grade 316) were inserted through the vertical wall of the mould to an inner penetration depth of 5mm, with each pin protruded 8mm from the external surface to facilitate alligator clip connection. This cell, hereafter referred to as the water cell, was used to perform two trial tests described in more detail in Section 3.4. The same cell was then used to monitor moisture ingress in concrete, but with a 60mm diameter PVC pipe added to the centre of the base-plate, in order to form a centre hole into the sample (discussed below), referred hereafter to as the concrete cell.

The mix proportions used in the experimental program are presented in Table 1. The mix had a water/cement (w/c) ratio of 0.7 and used CEM I 52.5N cement clinker to EN197-1 [29] as the binder. The oxide composition of the cement is presented in Table 2. A graded crushed granite coarse aggregate ( $\leq 10\text{mm}$ ), fine aggregate ( $< 4\text{mm}$ ) and tap water were used. The coarse and fine aggregates were thoroughly washed prior to use to remove any silt and clay, and conditioned to a saturated, surface-dry state. A hollow cylinder (i.e. the PVC pipe noted above) was cast into the mould shown in Fig. 3(b), together with three 100mm cubes for compressive strength tests.

During fabrication, fine aggregate, cement, and water were initially mixed in a 10-litre Hobart planetary mixer for 2 min. The coarse aggregate was then added into the mixing bowl and mixed manually for a further 5 min. The fresh concrete was then cast into the PVC mould and compacted on a vibrating table. Immediately after compacting, the top surface of the specimen was covered with plastic sheeting to prevent evaporation. The plastic sheeting was removed after 24h and the specimen was then submerged in water in a controlled laboratory environment ( $20\pm 2^\circ\text{C}$ ) for a further 27 days; after this time, the inner PVC pipe was removed and the top and bottom surfaces were then sealed with two coats of an epoxy-based paint to facilitate one dimensional drying and wetting. The specimen was then left in the laboratory ( $55\pm 5\%$  RH) for 3 months, in order to allow the specimen to dry naturally from the centre hole. It was noticed that part of the internal wall of the centre hole sustained a certain degree of surface damage during the PVC-tube removal process, as indicated by the rather rough and uneven surface (see Fig. 3(c)) observed primarily between electrode positions 2 and 5 (see Fig. 1).

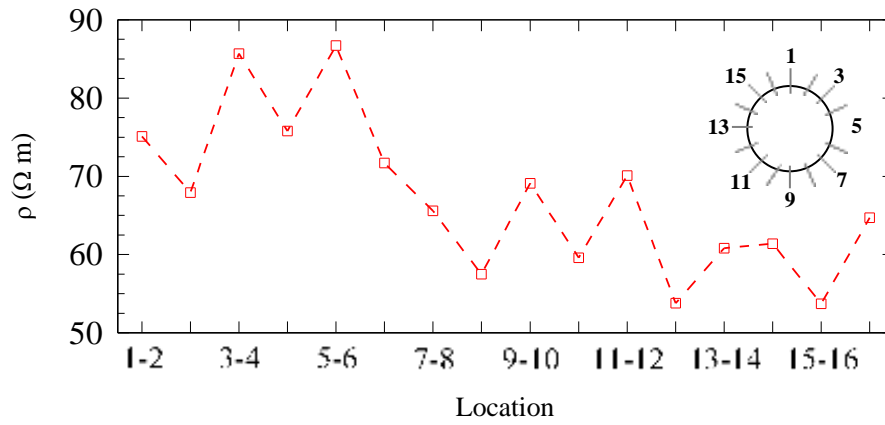
**Fig. 4** Resistivity variation along the outer circumferential surface after 3-month drying in the laboratory environment ( $20 \pm 2^\circ\text{C}$ ,  $55 \pm 5\%$  RH).

In order to obtain an indication of the extent of the damage, Fig. 4 presents the resistivity of the concrete,  $\rho$  ( $\Omega\text{m}$ ), for each electrode pair after the specimen being left in the laboratory environment for 3 months. The resistivity was obtained from the measured electrical resistance of the concrete,  $R$  ( $\Omega$ ), and a calibration factor which was first determined by electrical measurements on solutions of known resistivity placed within the test-cell shown in Fig. 3(a) prior to casting. As surface defects could be expected to alter the drying processes, this would have the effect of changing the level of pore saturation and thereby altering the resistivity of the concrete in this region. Considering Fig. 4, it is evident that the average resistivity values between electrodes 1 and 6 are approximately 25% higher than those of the remaining part of the specimen, indicating that the concrete in that region is in a drier state than the remaining part of the specimen.

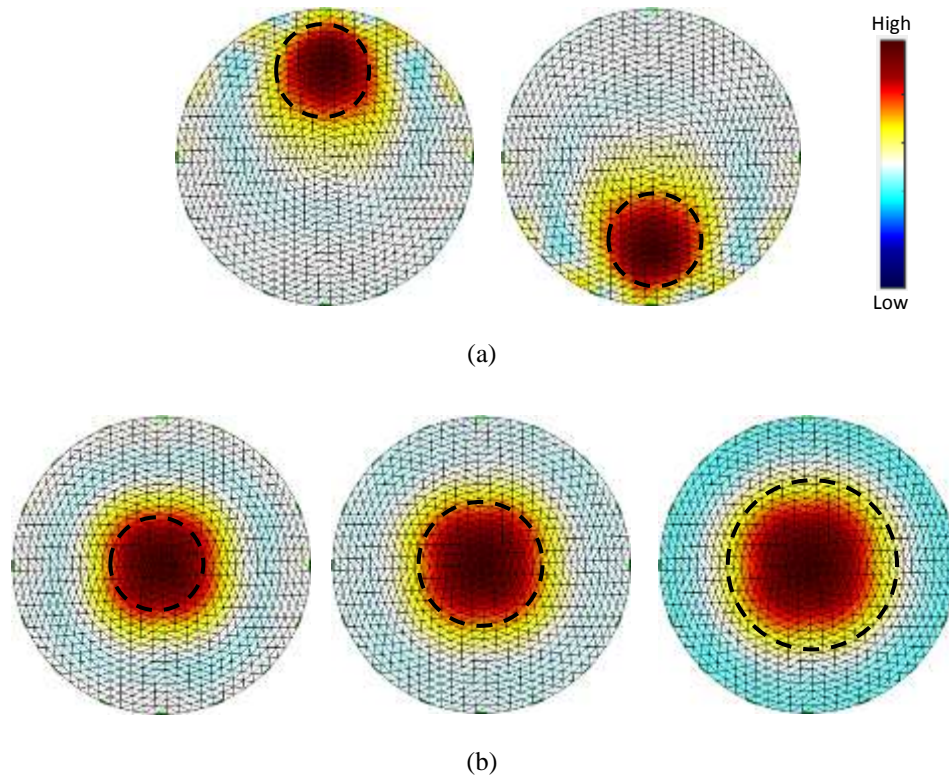
**Fig. 5** Reconstructed images of difference sizes of PVC pipe placed at different positions in the test cell: (a) a 48-mm PVC pipe positioned in front of electrode 1 and 9; (b) a 48-mm, 64-mm and 88-mm pipe positioned at the centre of the cell. The actual position of the PVC pipe is denoted with a dashed line. The colour bar is provided, with dark red representing a significant relative increase in resistance, white representing no relative change, and dark blue representing a significant relative decrease in resistance.

Figure 5(a) compares the reconstructed images and the actual position of the 48-mm diameter PVC pipe which was placed in front of electrode 1 and 9, respectively. It is evident that the actual position of the PVC pipe, which is indicated by a dashed line, is represented by a region of high resistivity (dark red and red), surrounded by a less-resistive region (yellow) and a weak development of slightly conductive zone (cyan) – an artefact feature called ringing/overshoot [32]. Another weak development of smeared artefact could also be seen near the boundary, as indicated by the region of a less-resistive region (yellow) in front of either electrodes 16, 1 and 2 or electrodes 8, 9 and 10. Despite the development of these artefacts in the background, a reasonable accuracy is indicated.

Figure 5(b) presents the results of further verification for detecting a PVC pipe of different diameters placed centrally within the test cell, with the actual size of the pipe indicated with a dashed circle. Considering that the

boundary of the region of high resistivity (red) representing the actual size of the pipe (as shown previously in Fig. 5(a)), it is evident from this Figure that the adopted technique, whilst the sensitivity at the centre can be expected at the lowest [33, 34], is still capable of detecting the change in pipe diameter. Again, reasonable accuracy is indicated, although the technique tends to overestimate the size of the smallest pipe (48mm) and underestimate the size of the largest pipe (88mm). It is also evident that the resistance along the boundary region decreases, particularly when the 88mm PVC pipe is used. This is again a 'ringing' reconstruction artefact and represents the limitation of the current system, provided that the same water was used as the background medium.

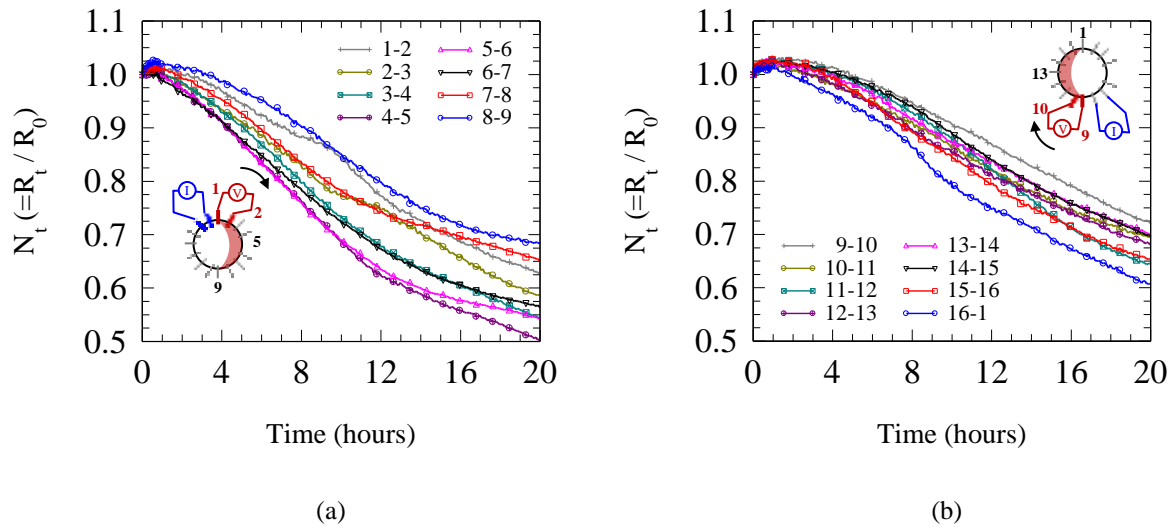
**Fig. 6** Normalized resistance during the initial 20-hours, with measurements taken from two adjacent pairs of electrodes along the outer circumferential surface: (a) data obtained from the right-half side of the specimen (between pins 1 and 9, in clockwise direction); and (b) data from the other half of the specimen.

The electrical response of the concrete is firstly presented to assist interpretation the results obtained from the tomography measurements. The change in *normalised* resistivity over the initial 20-hr period of absorption is presented in Fig. 6, with only data from two adjacent pairs of electrodes being plotted for illustrative purposes. The normalised resistance is defined as the ratio  $R_t/R_0$ , where  $R_t$  is the resistance at time,  $t$ , and  $R_0$  is the resistance just before the water being poured into the centre hole. For clarity, the values obtained from the right-half side of the specimen are presented in Fig. 6(a), whereas those obtained from the left-half side are presented in Fig. 6(b).

It is evident from these Figures that as water is absorbed into the concrete, normalised resistivity values display a general decrease with time, with the concrete close to the inner surface defect (between electrodes 2 and 6) undergoing more significant reductions. Consider, for example, readings obtained from electrodes 4-5 in which  $N_t$  remains constant until about 1 hour; at 4-hrs,  $N_t$  has reduced to 0.9; 0.75 at 8-hrs; 0.62 at 12-hrs; ~0.55 at 16-hrs; and ~0.5 at 20-hrs. Electrodes 8-9, on the other hand, display a detectable increase in resistance before decreasing to the initial value before wetting at about 3.5-hrs; at 8-hrs,  $N_t$  has decreased to 0.9; 0.8 at 12-hrs; ~0.7 at 16-hrs and ~0.68 at 20-hrs. Similarly, electrodes 9-10 display a slight increase in resistance (up to 3%) before decreasing to the initial value before wetting at ~5.5-hrs; at 8-hrs, however,  $N_t$  has only decreased to 0.95; 0.87 at 12-hrs; ~0.8 at 16-hrs; and 0.72 at 20-hrs. The increase in resistance noted above could be due to the fact that as the water moves into the partially saturated concrete, it *pushes* air into the pore system thereby causing a transitory increase in resistance [35, 36].

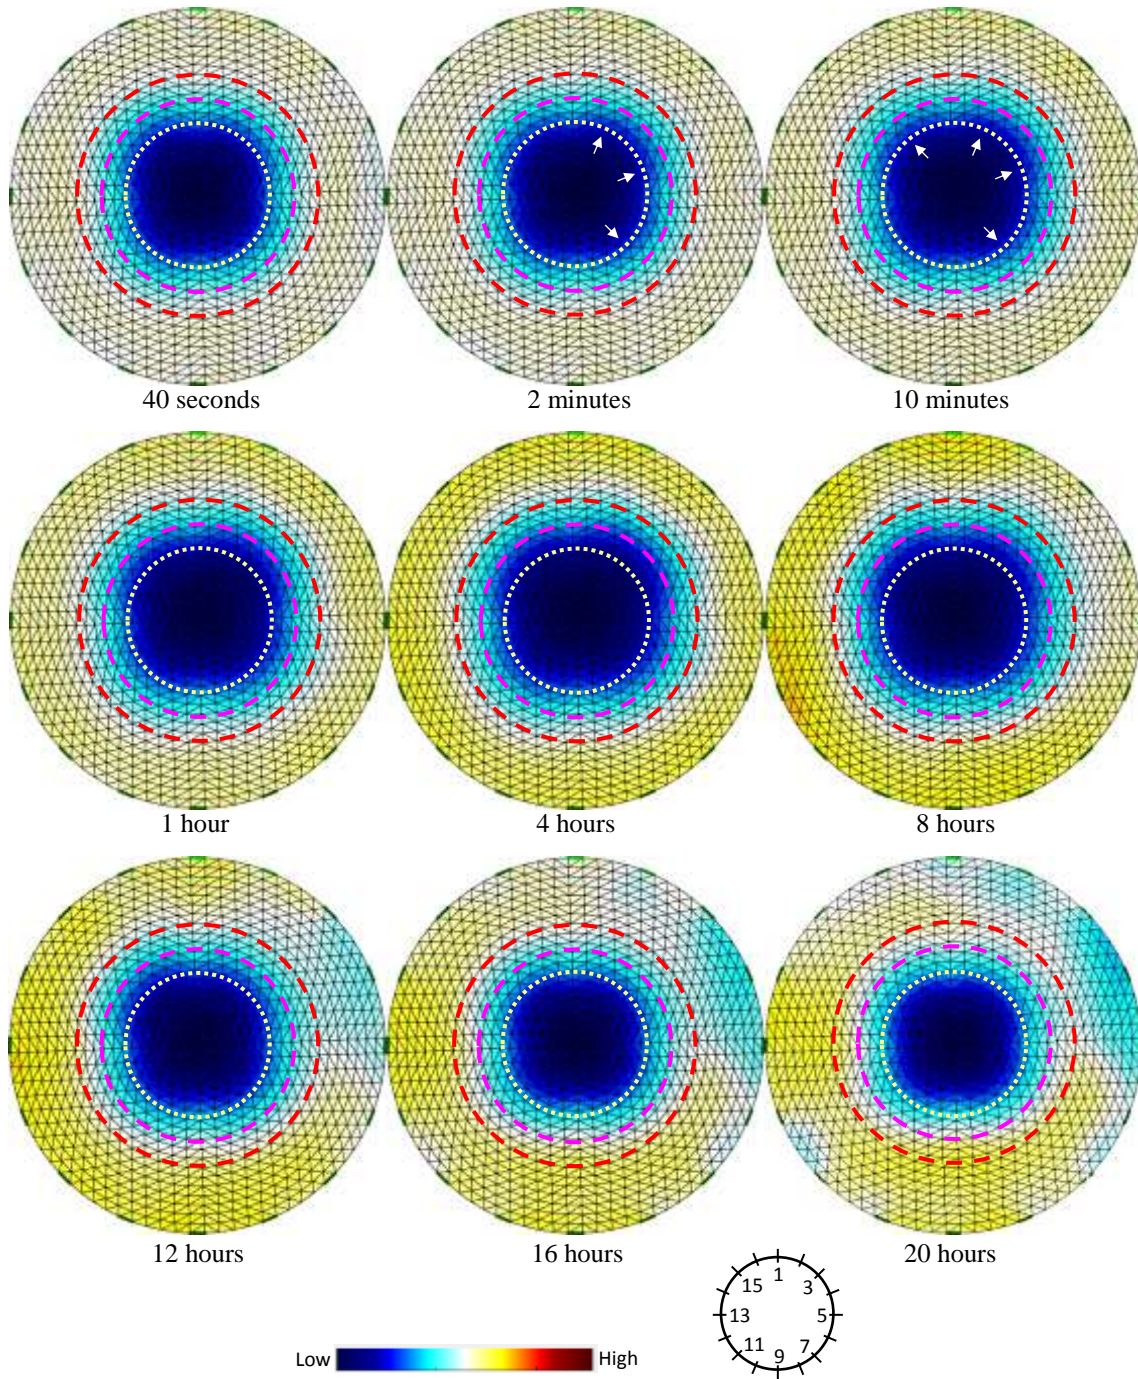
**Fig. 7** Reconstructed images during absorption. These images show the preferential movement of water into the damaged inner surface region.

Figure 7 displays the spatial distribution of electrical resistance within the hollow concrete cylinder over the 20-hrs after gauging, with all images reconstructed based upon the reference image which was processed from the measurements just prior to wetting. For illustrative purpose, the actual diameter of the hole (60mm) is indicated by a dotted circle, with two other dashed circles added to indicate a depth of 10mm and 20mm from the exposed (internal) working surface. It is evident from this Figure that the water in the central cavity is represented with a region of low resistivity (blue).

As the water permeates through the concrete, a traceable decrease in resistivity should follow the water front and the reconstructed images over time would, therefore, depict a blue area of low resistivity gradually expanding outwards. Examination of the images presented in Figure 7 reveals that although not that obvious, there is a general progressive enlargement of the blue region with time, particularly over the initial 4-hrs absorption. The enlargement in diameter implies that the bulk resistivity of the concrete within the surface zone (i.e., ~20mm from the exposed surface) must be higher than the resistivity of the tap water ( $\approx 170 \Omega\text{m}$ ). Given that the bulk resistivity of the concrete measured from the outer circumferential surface is within the range 53–88  $\Omega\text{m}$  (see Fig. 4), which is lower than the tap water, this would indicate the presence of a moisture gradient through the concrete. This occurred as the PVC mould was left in place over the entire period of drying prior to the absorption test. This feature is well-documented and has been observed in the cover-zone of concrete when subjected to drying [22, 23, 35, 36]. The slight enlargement in diameter over the initial 4-hrs is not entirely unexpected as the ingress is primarily driven by the moisture gradient.

The influence of drying on water ingress can also be seen from the initial wetting period. During the initial 10-min absorption, for example, it is evident from Fig. 7 that the centre region increases in size at a faster rate than the remainder of the test period which reflects the influence of capillary suction forces resulting from the extended period of drying. The enlargement is more prominent along the directions indicated by arrows due to the presence of the damage to the internal wall of the core region, indicating the preferential movement of water into the inner damaged surface region.

With reference to Fig. 7, it is apparent that the progressive enlargement of the core region is also accompanied by a gradual increase in resistance along the sample boundary, as evidenced by the slight yellow tint which then

gradually turns to darker yellow. This increase in resistance may be a measurement artefact (ringing effect), provided that the normalized resistance displayed an overall decrease in values, although as discussed in section 4.2.1 above, the yellow tint ring may correspond to the slight increase in resistance resulting from the air being pushed into the pore system during the initial few hours of wetting (see Fig. 6(b)). Other supporting evidence from the measurement artefact can be obtained from Fig. 5(b) highlighting that the 'ringing' effect becomes more pronounced as the pipe diameter increases.

Finally, it is interesting to note from Fig. 7 that the increase in resistance between electrodes 2 and 6 appears to cease after approximately 8-hrs absorption. This would, once again, reflect the preferential movement of water into the inner damaged surface region, causing an increase in the degree of pore saturation and thereby decreasing the bulk resistance of the concrete (see the reconstructed images at the remainder of the test period). At 12-hrs, it is evident that the concrete between electrodes 2 and 5 was, indeed, less resistive than the remaining part of the concrete, as indicated by the white and light blue contours. At 20-hrs, it is apparent that this region has increased in size, extending further in the counter-clockwise direction to electrode 16 and in the clockwise direction to electrode 7, which all in agreement with the relatively lower resistance values obtained from direct 4-pt measurements (see Fig. 6). It is observed that another less-resistive region begins to form between electrodes 11 and 12 toward the end of the test period.
